Research Paper: Evaluation of the effect of three different post etching surface treatments of feldspathic ceramic on the shear bond strength to composite resin

Keywords: porcelain,
shear bond strength,
composite resin

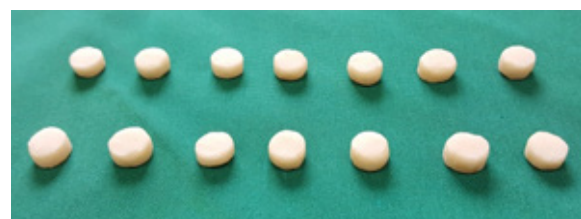
Figure 1 porcelain discs

Porcelain firing was conducted 5 times for each sample in order to control porcelain shrinkage and preventing crack formation in refractory plaster. (Fig 1)

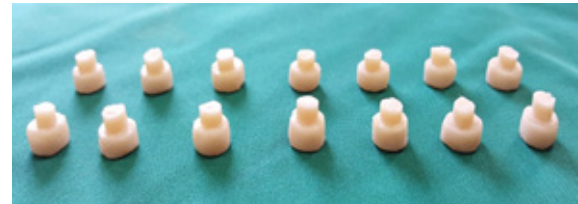
Figure 2 porcelain specimen after bonding to composite

The first increment was polymerized for 20 seconds. The last increment was cured for 30 seconds according to the manufacturer's instruction. (Fig 2) It should be noted that one operator performed all the procedures and a calibration of the LED light intensity was performed after every 2 times using of the light-curing device.
